**Report 2465**

## Ported-Coax Interior Sensor (PINTS)

Authored By: Marvin D. Robertson

Report Date: June 1988

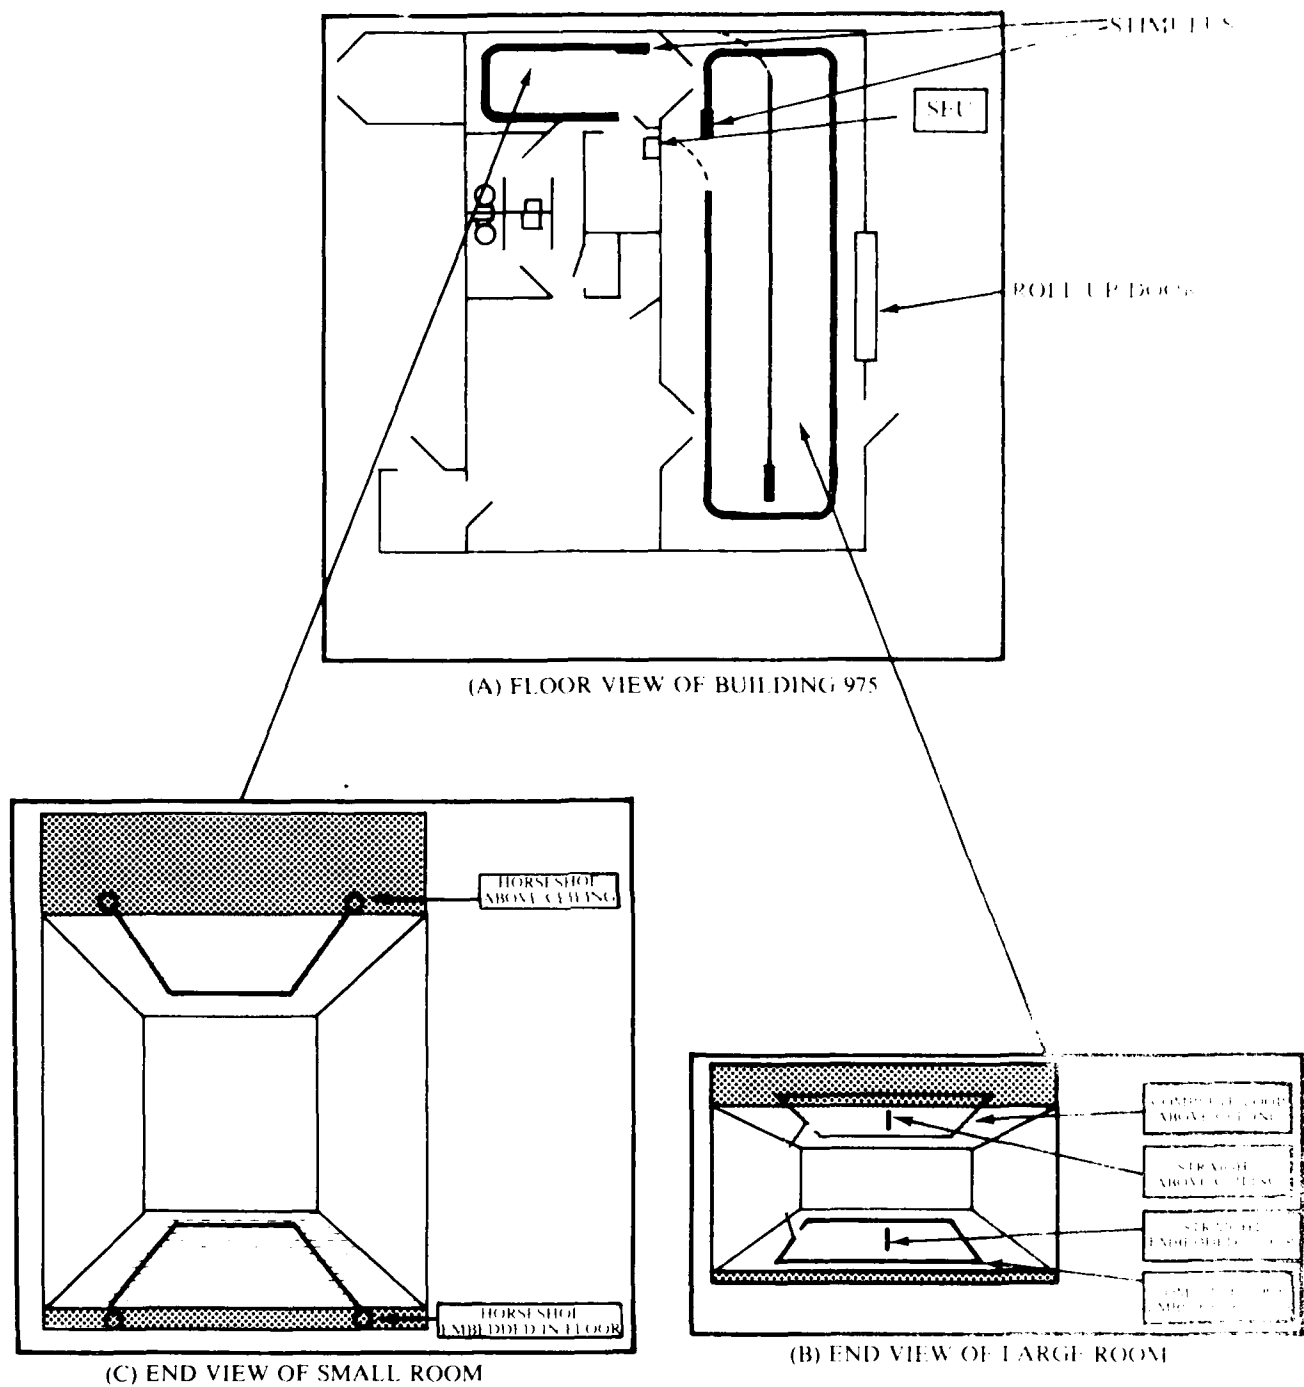
Figure 4. Original Cable Configuration, Building 975

There were at least two possible sources of the Antenna Effect present in Building 975. The first was the suspended-grid ceiling, and the other was electrical equipment wiring such as switches, thermostats, and telephone equipment. All of these sources were located within the PINTS RF field. The Antenna Effect was found to be a very significant problem. The installation of the PINTS cable caused the suspended ceiling to be the primary contributor to the Antenna Effect (see Figure 7). It was constructed of hundreds of metallic elements, each approximately 2 feet in length, and each capable of making electrical contact with other elements. The PINTS 60MHz carrier frequency has a corresponding wavelength of 16 feet and a 2 foot conductor (one-eighth wavelength) could easily perform as an antenna element. The team conducted several experiments to produce a force on the ceiling in an attempt to cause the PINTS to alarm. The investigation team had great success in causing the system to alarm by applying very small forces to the ceiling. Normal temperature and pressure changes could also exert a small force on the ceiling which could cause the system to alarm. Electrical appliances or AC wiring to such appliances within the PINTS RF field were observed to cause alarms when the appliances' thermostats changed state, whether or not AC power was applied. Also, telephone equipment within the PINTS RF field was observed to cause alarms. Telephone equipment included line-connect relays which, when actuated, changed the lengths of many conductors in the building.

After extensive data collection and analysis, it was determined by the investigation team that the most significant cause of the high FAR/NAR rate was due to the Antenna Effect in which the suspended ceiling was the major contributor. An attempt was made by the team to isolate the detection zones from the suspended ceiling. The following are the different zone configurations used in an attempt to isolate the detection zones from the suspended ceiling:

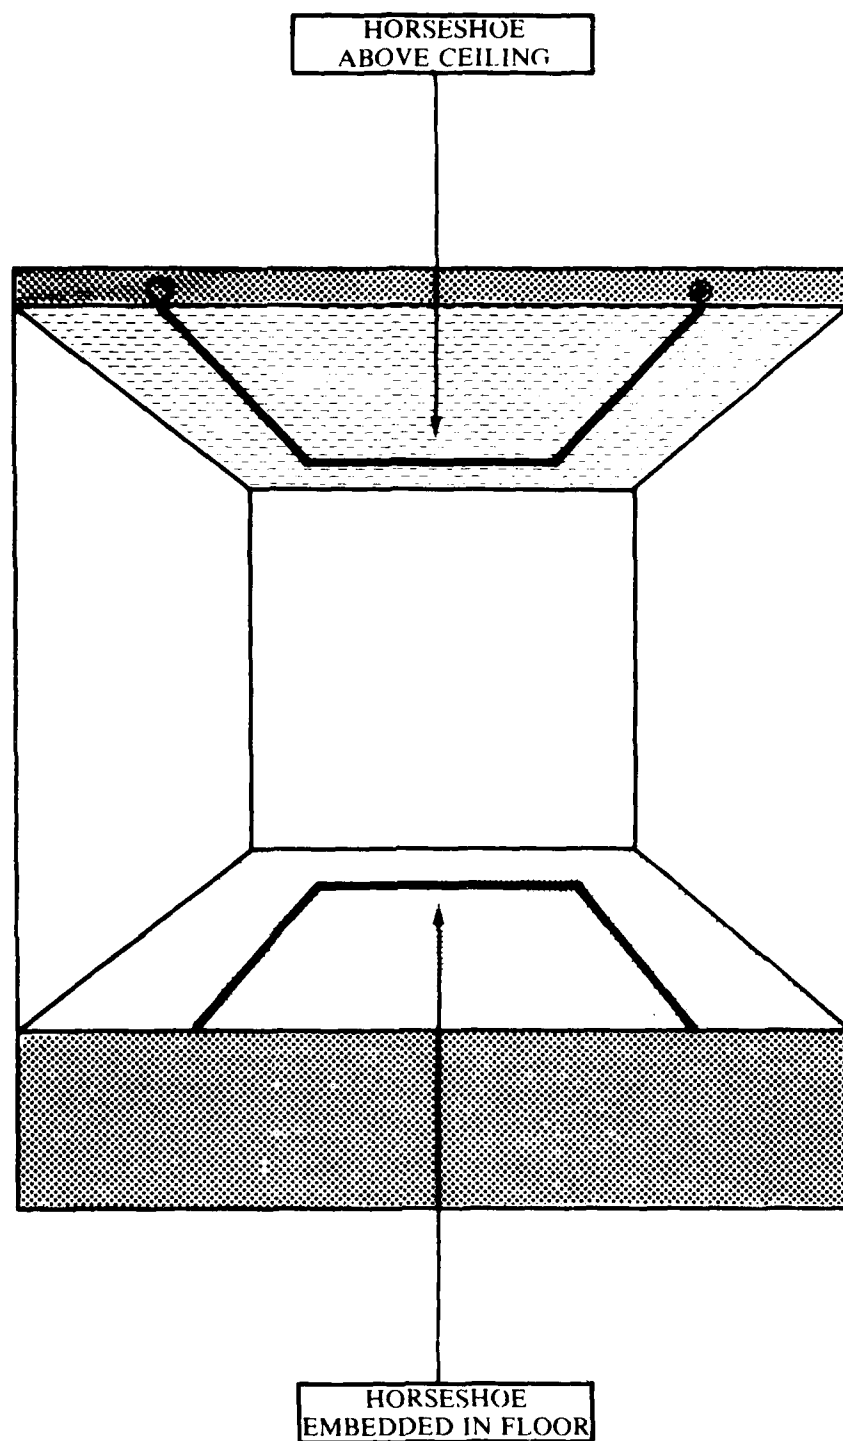
**Figure 7. Transmit Cables Above Suspended Ceiling  
Receive Cables Embedded in Concrete Floor**

This was found to be a very significant problem. The suspended ceiling was the primary contributor. As noted above, the ceiling's metal grid is constructed of hundreds of metal elements, each approximately two feet in length, and each capable of making unpredictable electrical contacts with neighboring elements. The PINTS-II uses a carrier frequency of 60MHz, with a corresponding wavelength of 16 feet. A two foot conductor (one-eighth wavelength) can easily act as an antenna element.

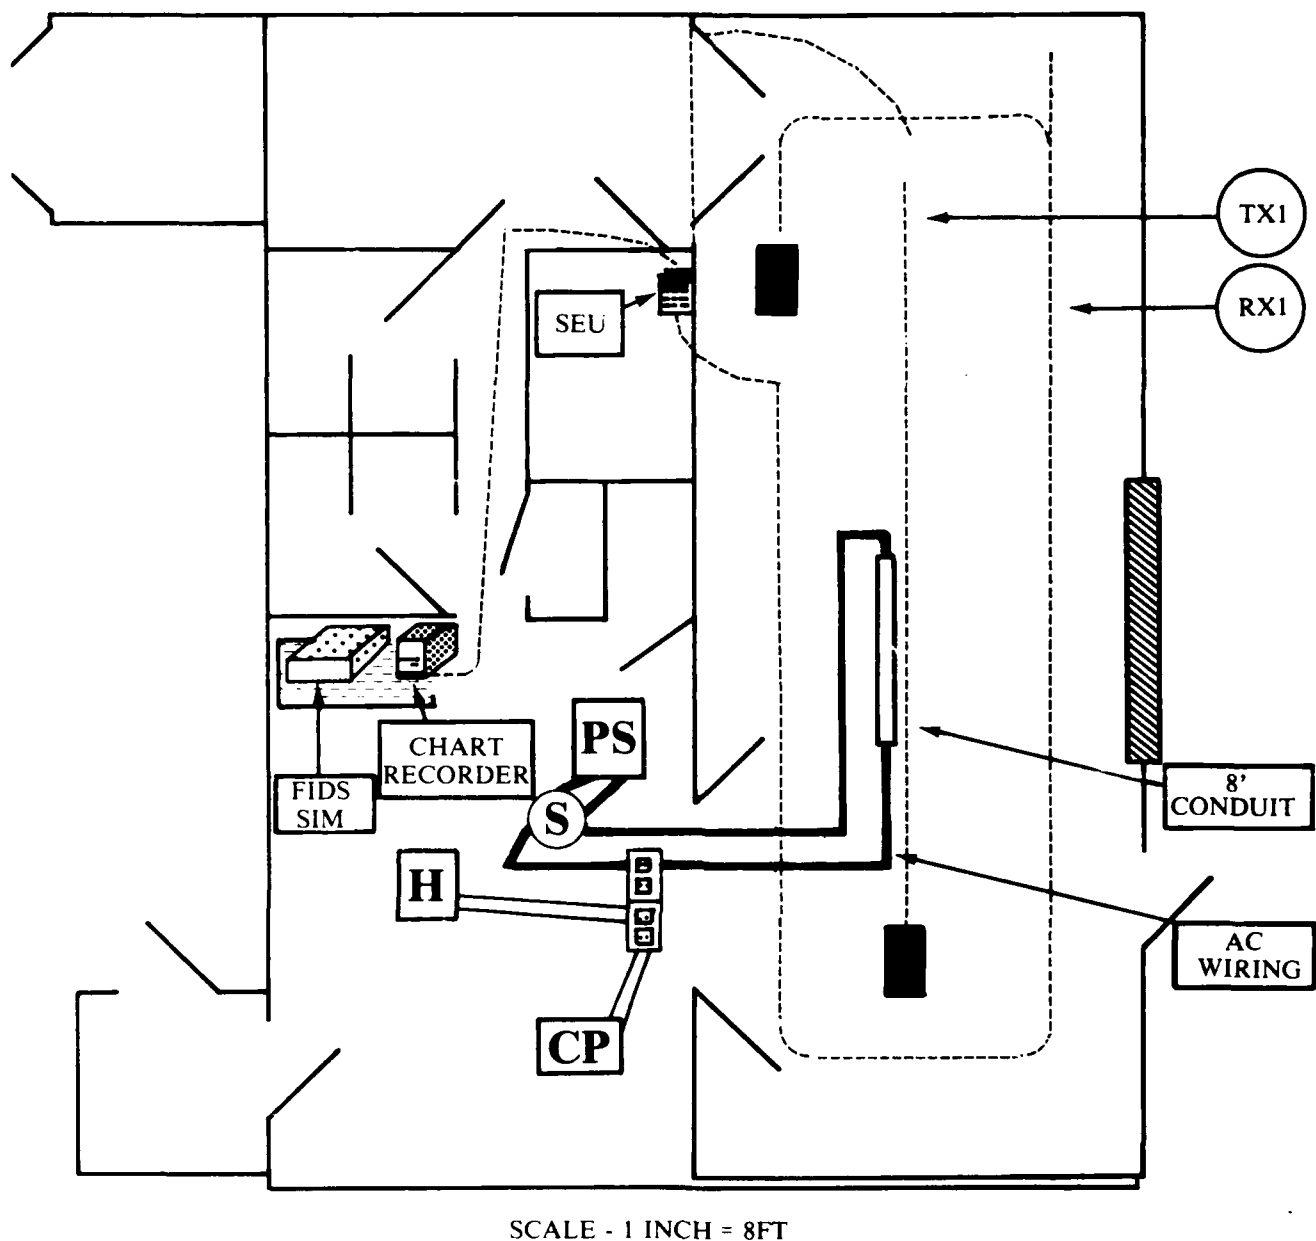
Figure 8. Controlled Environment Setup in Large Room

The second series of tests involved gathering data from a controlled and stable environment. The detection zones in the large room were reconfigured (see Figure 8). The new transmit (Tx1) cable was the center cable embedded in the floor and the new receive (Rx1) cable was the outer perimeter embedded in the floor. Several causes of false alarms were postulated by EG&G (see Appendix B) and are listed below:

The new cable configuration (the floor pair) proved to be the most stable configuration achieved and was monitored undisturbed for a total of 84 hours (see Table 1). During this monitoring period, only one false alarm was observed and recorded.

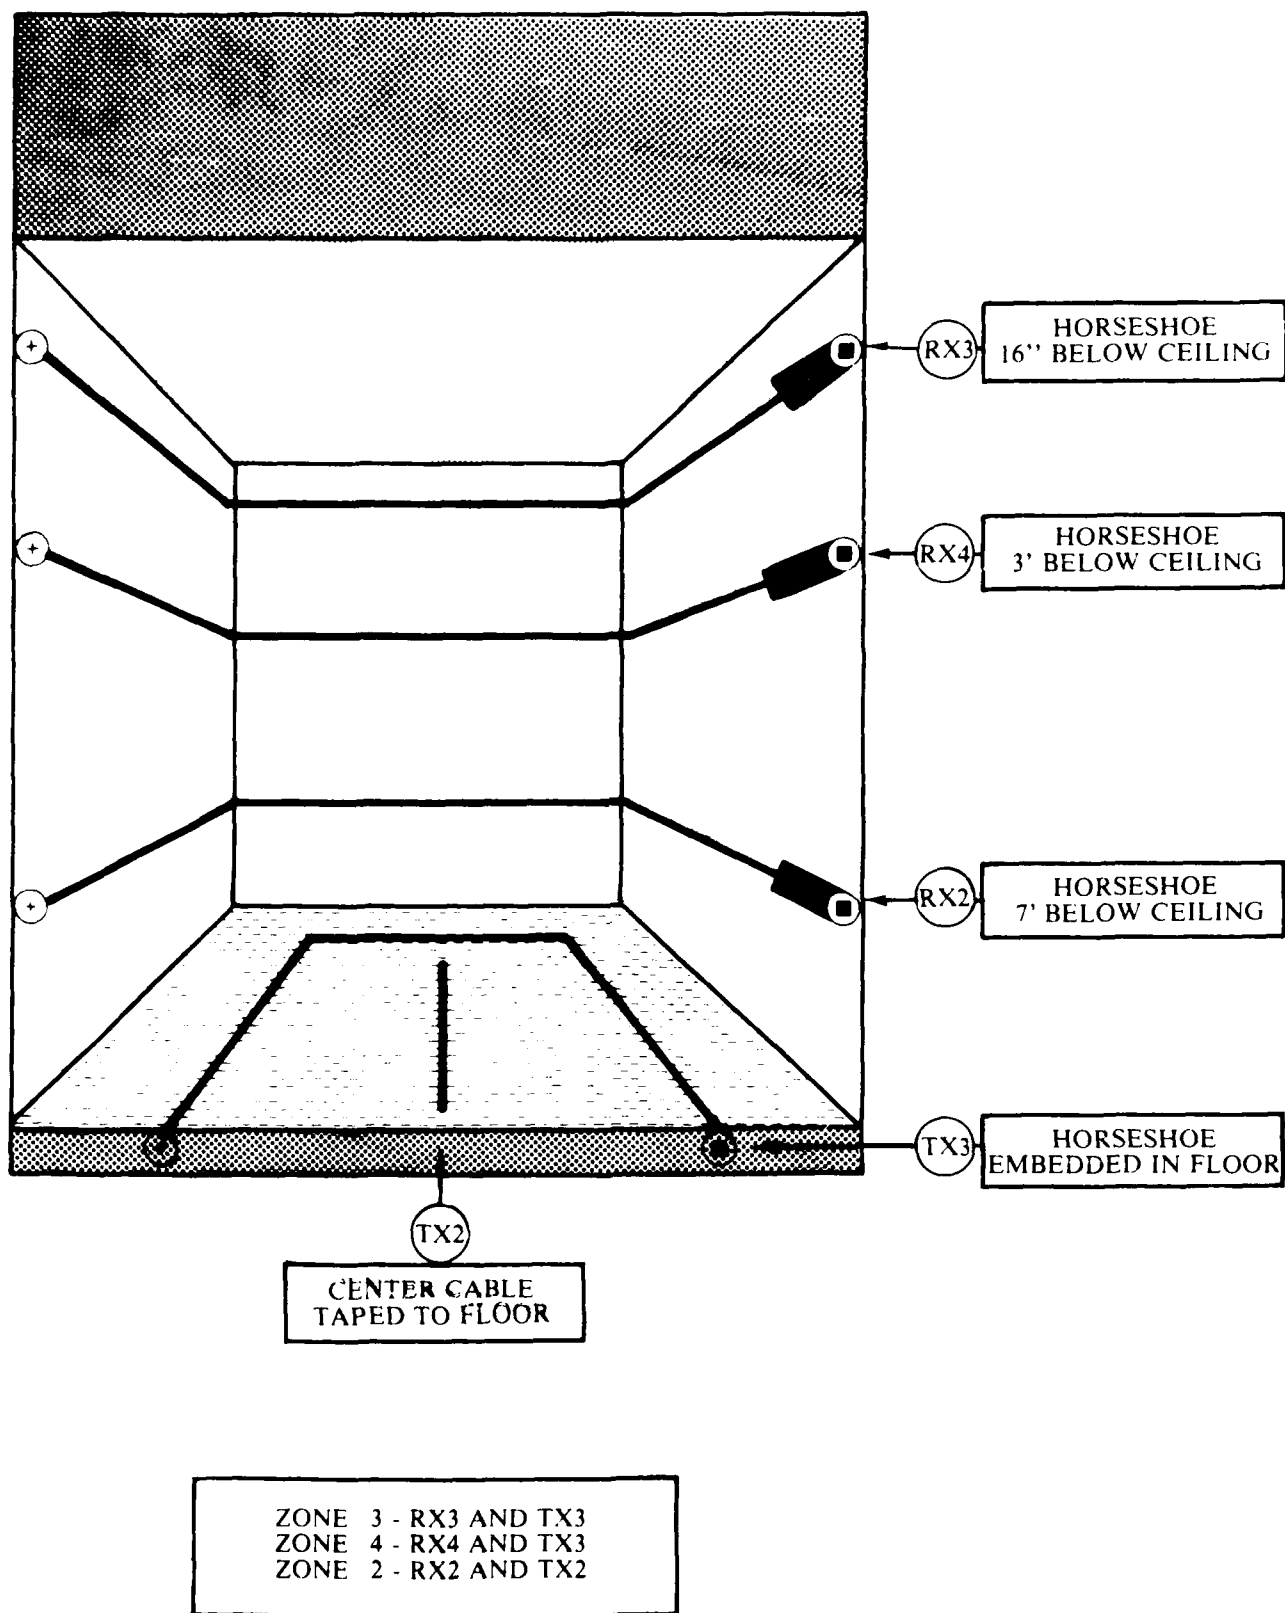
Figure 9. Small Room Cable Configuration

1. The first configuration was to create a detection zone inches below the suspended ceiling. A new receive cable (Rx3) was taped to the walls in the small room 16 inches below the suspended ceiling (see Figure 9). Transmit cable (Tx3), embedded in the floor in the small room, was remapped to communicate with Rx3. This pair was referred to as Zone 3.

2. The next configuration was to deploy another cable approximately 3 feet below the suspended ceiling. This receive cable (Rx4) was taped to the walls in the small room. Tx3 was also used to communicate with Rx4 (see Figure 9). This cable pair was referred to as Zone 4.

3. The third configuration was to create a zone approximately 1 foot from the floor. Receive cable Rx2 was taped on the walls approximately 7 feet from the ceiling in the small room. A new transmit (Tx2) cable was also taped to the floor in the small room and was mapped to transmit to Rx2 as Zone 2 (see Figure 9).

All data was analyzed and evaluated by the investigation team. A comparison chart was compiled to compare the collected analog output data obtained from the floor and wall cable pairs. Data collected during this testing series supported the theory that the suspended ceiling was the main contributor to the high FAR rate. The analog output readings collected during the monitoring period for the same event, seemed to be much lower for the cable zones farther away from the suspended ceiling (see Figure 13). Also, in accordance with data collected, the floor pair exhibited greater stability than any other configuration tested. A floor pair was designed for the small room and only one false alarm was reported during this test period. The floor pair configured for the large room reported no false alarm during the monitoring periods. The response to human motion (in terms of analog output) was much greater, and floor coverage for the room was greatly improved. COMDEV consulted with the designer of the PINTS cables and concluded that the HOT lead-in problems associated in the small room were likely arising from field coupling mechanisms that effectively made the lead-in HOT (sensitive) and extended the detection zone outside the room, thus allowing other sources, such as the water cooler and air conditioner, to generate alarms. Ferrite beads were used to deaden the HOT lead-in on the cables. The HOT lead-in problems only existed in the small room.

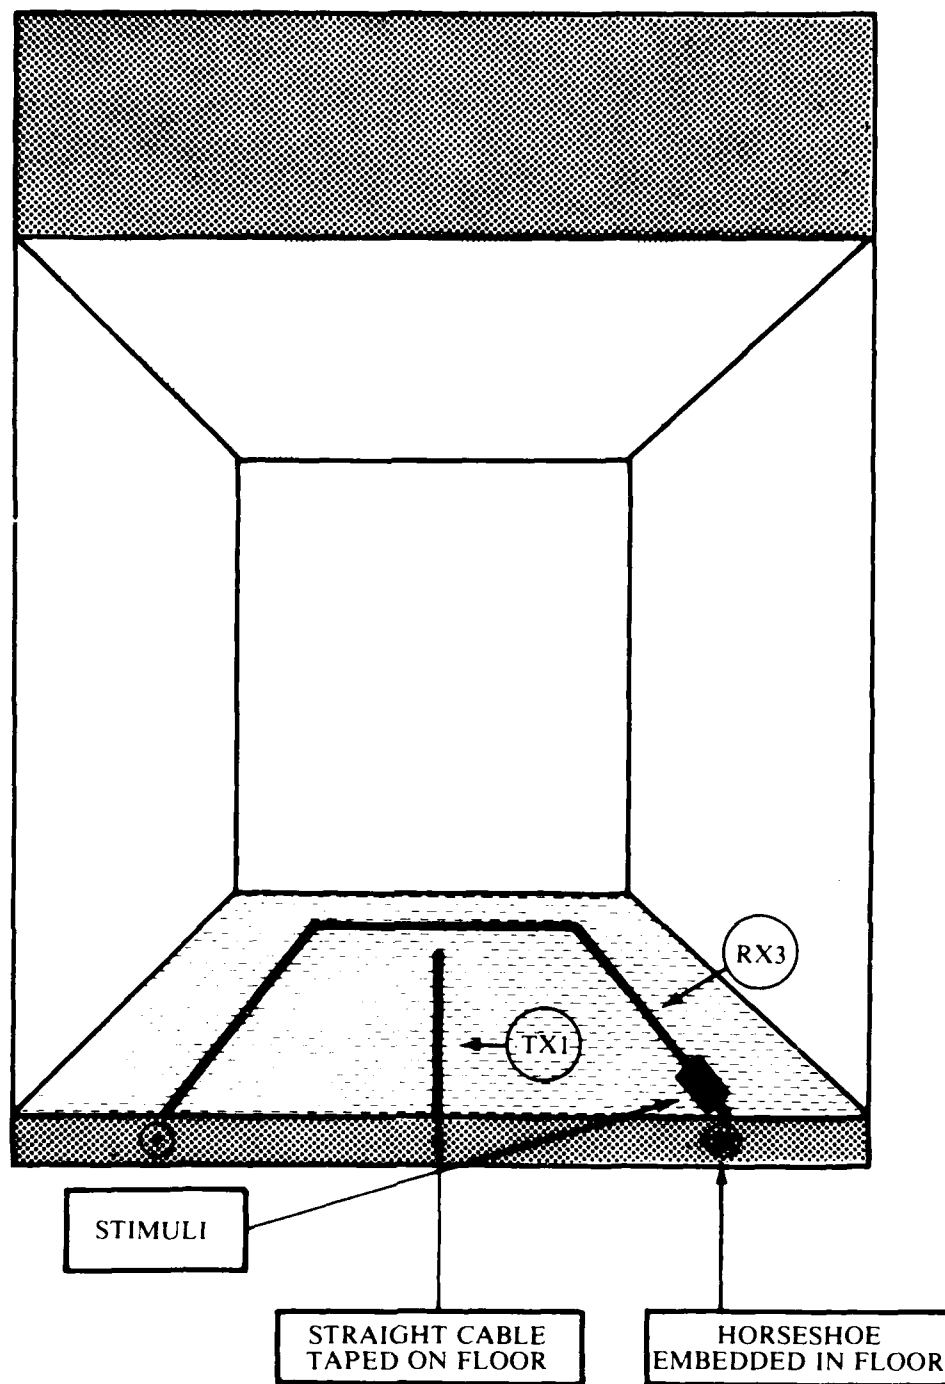
**Figure 10. Floor Configuration for Small Room**

4. The final configuration that was deployed in the small room was a floor pair. Transmit cable (Tx2) was taped to the floor and was remapped to communicate to receive cable (Rx3) embedded in the floor (see Figure 10). This pair created a new Zone 2 in the small room.
